INVENTORY OF MONUMENTS AT PAGAN

Volume One
Monuments 1-255

PIERRE PICHARD

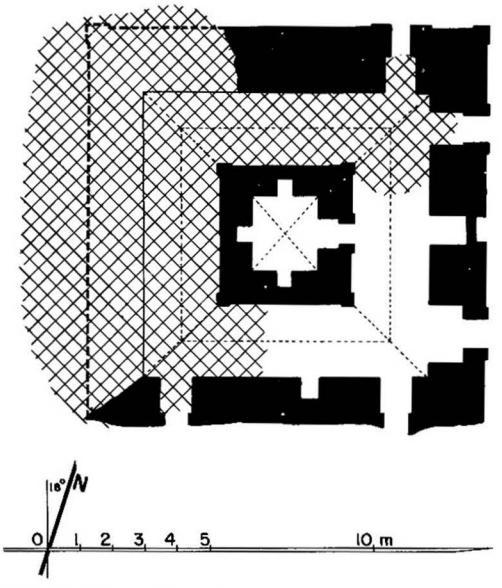
221 a2 - Ground-floor plan

5 present condition
- ruined.
- ground floor buried under debris.
- outer west wall collapsed.
- no maintenance.

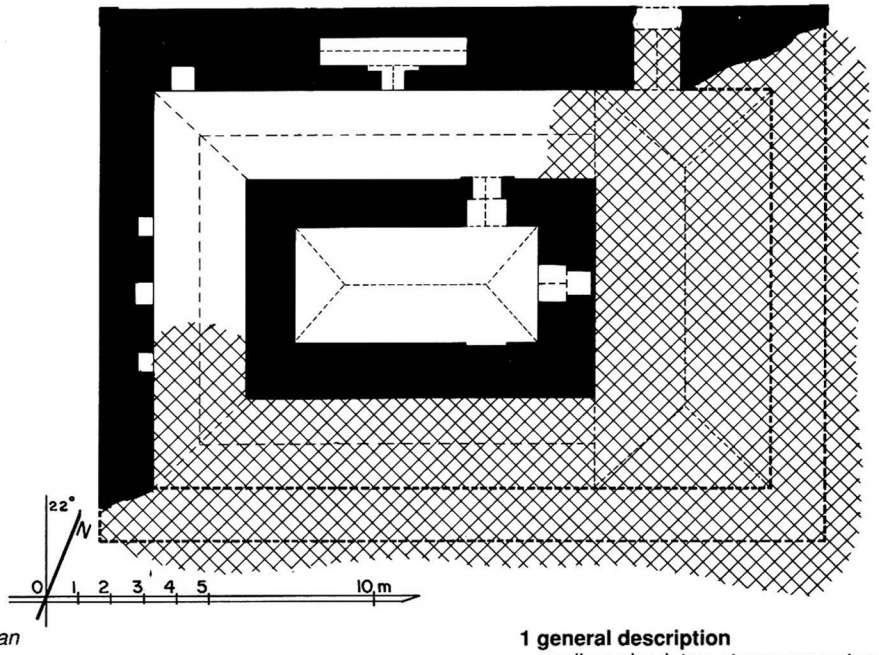
223 a - Plan

5 present condition
- ruined.
- vaults partly collapsed.
- east and south walls collapsed.
- ground floor buried under debris.
- no maintenance.

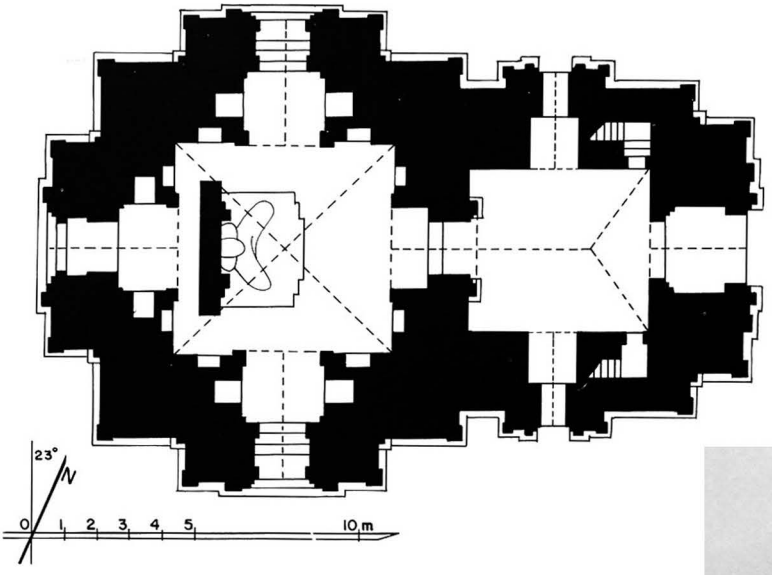
224 a - Plan

5 present condition
- no maintenance.
- arches cracked by the 1975 earthquake.

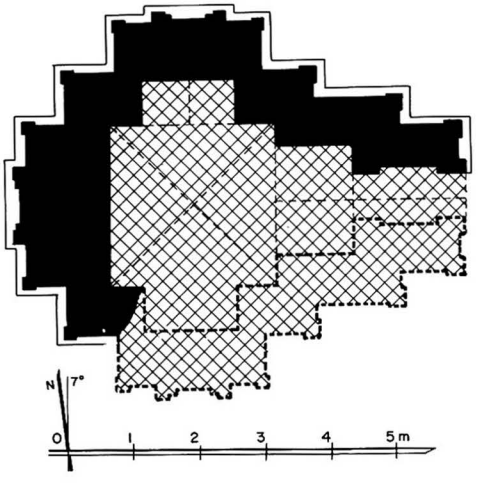
227 a - Plan

5 present condition
- ruined.
- vaults collapsed.
- ground floor buried under debris.
- south wall collapsed on 12.10.1983 after heavy rains.

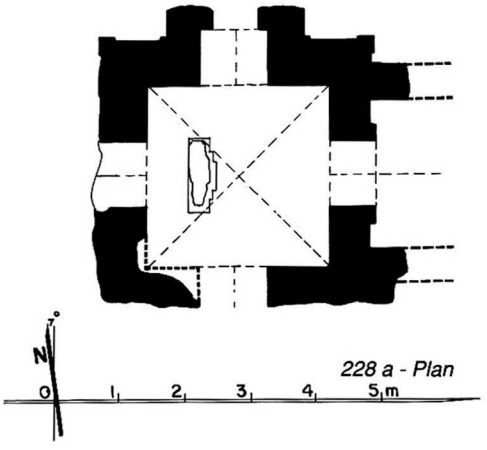
228 a - Plan

5 present condition
- ruined.
- entrance hall collapsed.
- ground floor buried under debris.

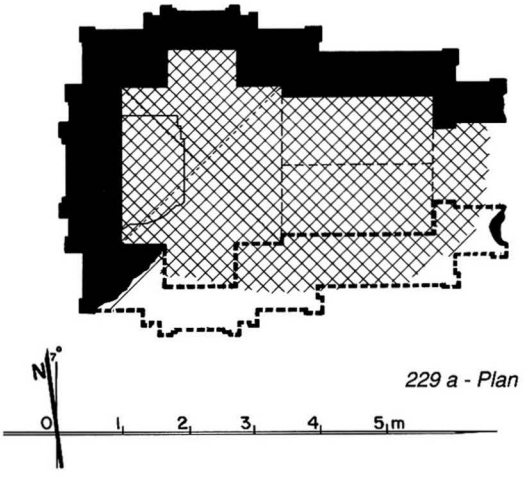
229 a - Plan

5 present condition
- ruined.
- vaults collapsed.

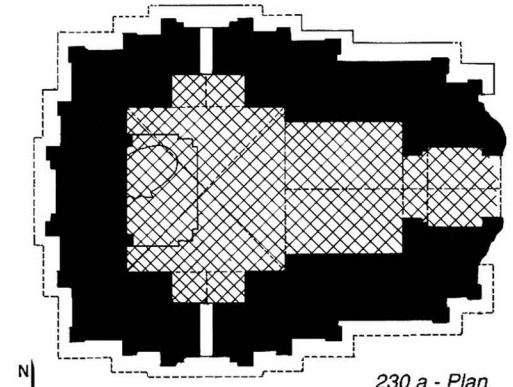
230 a - Plan

5 present condition
- ruined.
- ground floor buried under debris.
- north wall, vaults and upper parts collapsed on 11.10.1983 after heavy rains.

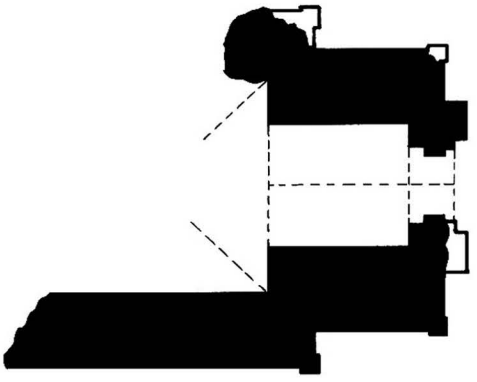
232 a - Plan

5 present condition
- ruined.
- north and west walls, vaults collapsed.
- ground floor buried under debris.

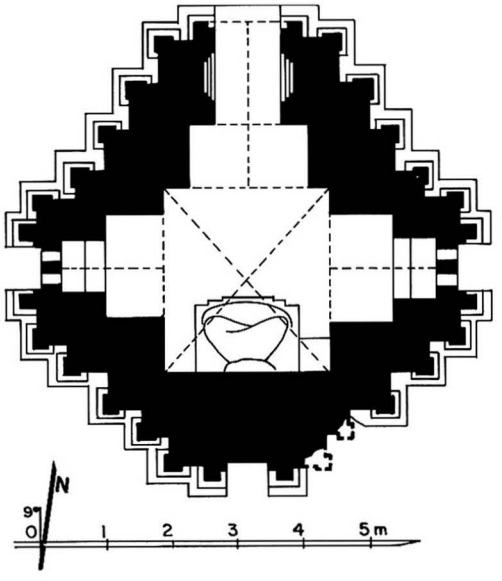
234 a - Plan

5 present condition
- maintained.
- eastern part of vault and wall collapsed on 11.10.1983 after heavy rains.
- repaired.

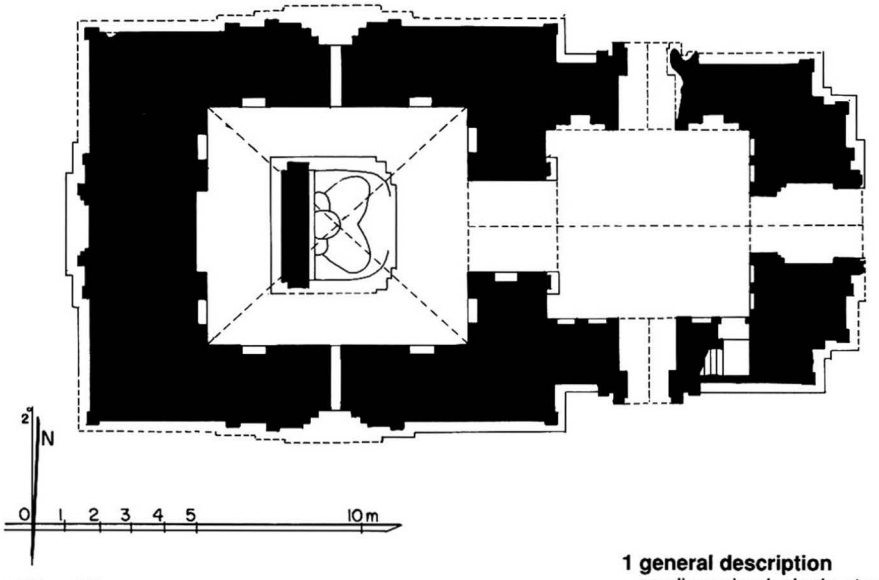
235 a - Plan

5 present condition
- maintained.
- severely cracked by the 1975 earthquake.
- repaired (Constr. Corp) 1984-85.

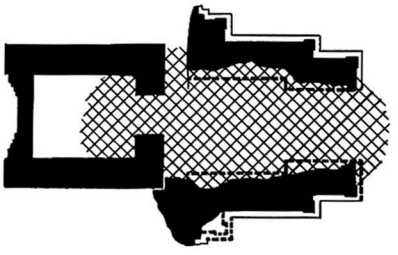
236 a - Plan

5 present condition
- ruined.
- no more trace of vaults.

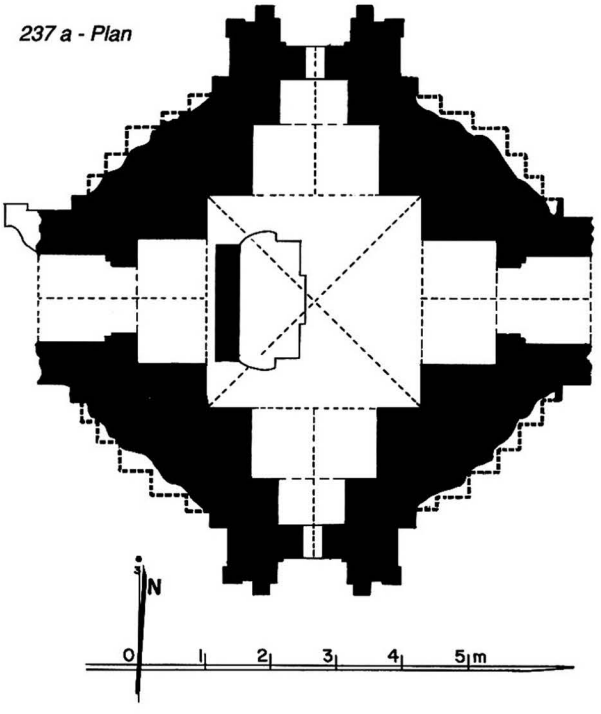
237 a - Plan

5 present condition
- half-ruined.
- facing disintegration.
- heavily damaged by the 1975 earthquake : partial collapse of vaults.
- emergency repair in 1983.
- upper parts collapsed between 1983 and 1990.

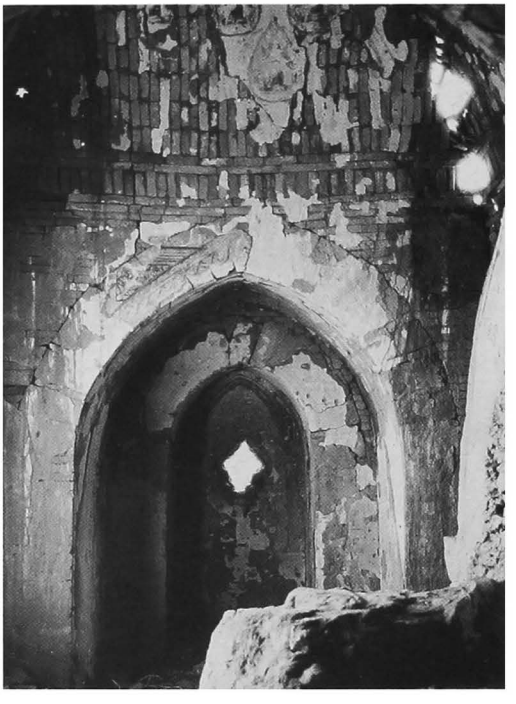
shrine :
- paintings disappeared.
- brick images in niches (damaged).

237 g - Shrine, south wall

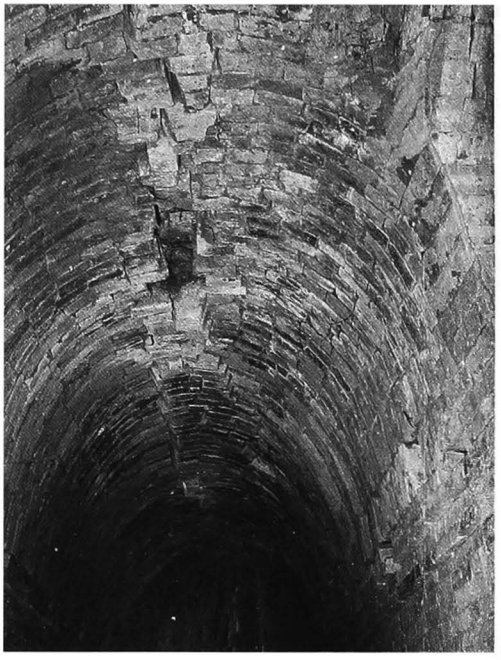
5 present condition
- upper parts heavily damaged by the 1975 earthquake.
- repaired and strengthened (Const. Corp.) 1984-85.

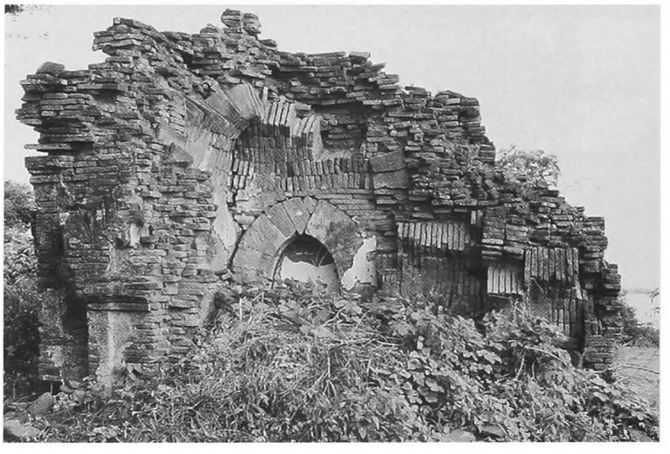
243 c - From south

5 present condition
- square tower destroyed by the 1975 earthquake.
- half-ruined.
- ground floor buried under debris.
- no maintenance.

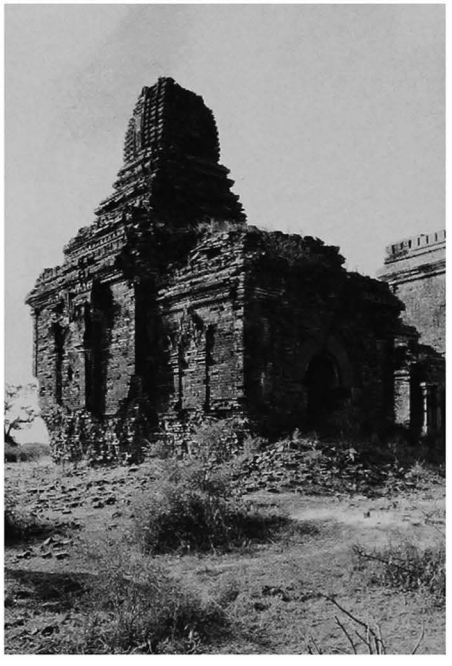
244 e - From south-east

5 present condition
- unevenly maintained.
- base disintegrating.
- east porch partly collapsed.

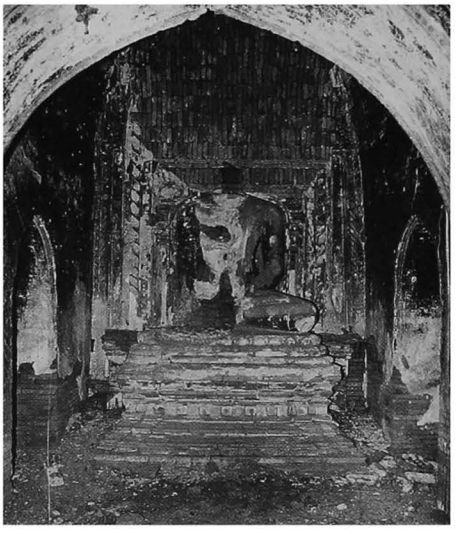
6 image
- 1 seated Buddha, facing east (damaged).

244 g - Image, from east

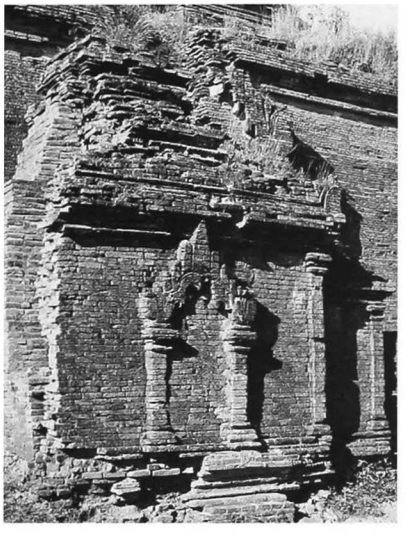
245 c - South face, from south-west (1983)

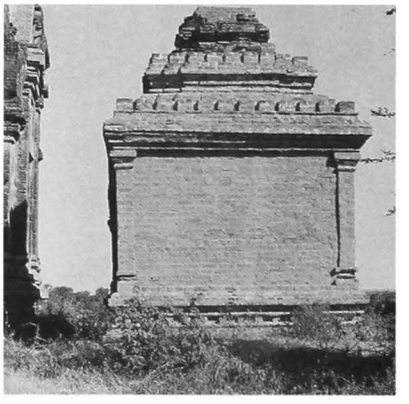
5 present condition
- square tower half-ruined.
- west wall collapsed during the 1975 earthquake.
- repaired (Const. Corp.) 1985.

245 e - West face, after repair (1990)

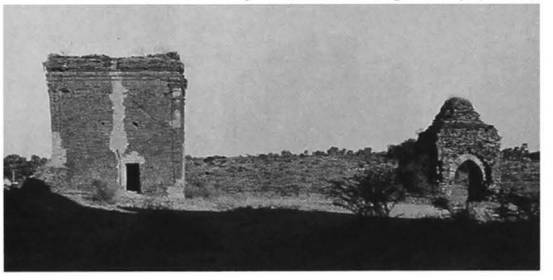
5 present condition
- no maintenance.

250 b - West face (1983)

250 d - South face (1983)

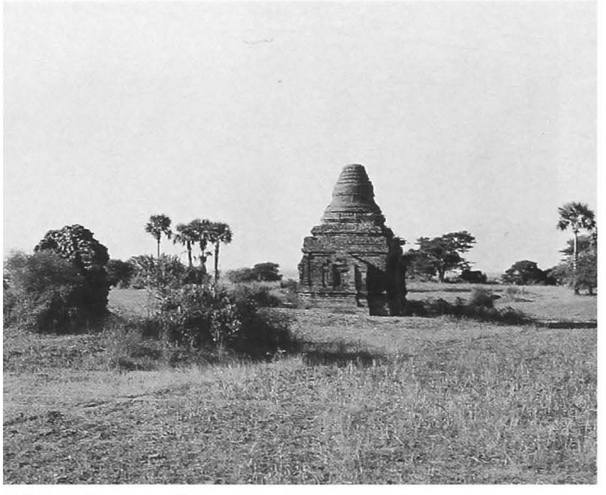
5 present condition
- ruined.

252 b - From south-east, together with 246

252 c - From south-east

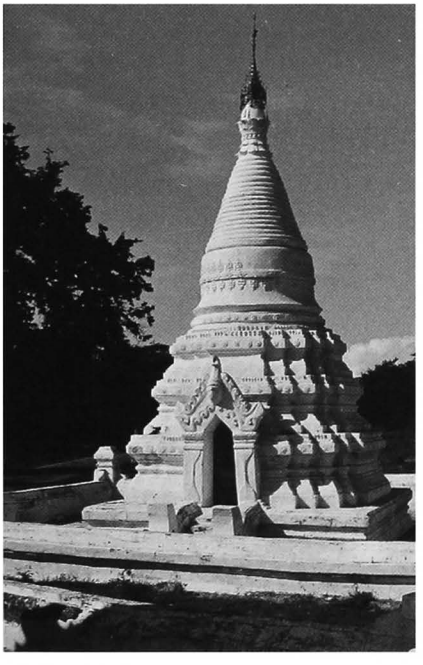
255 b - East face

5 present condition
- maintained by Trustees.
- whitewashed.

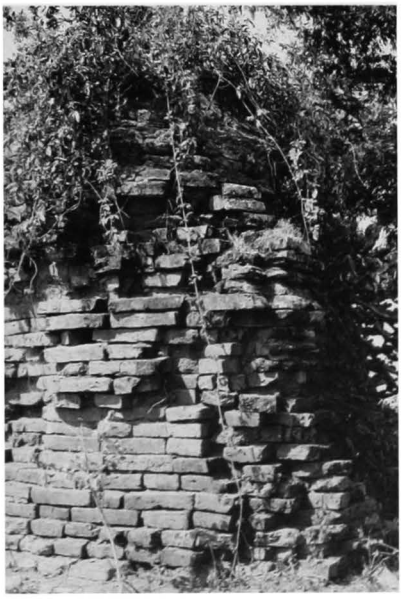
5 present condition
- half-ruined and endangered.

256 d - From north-east

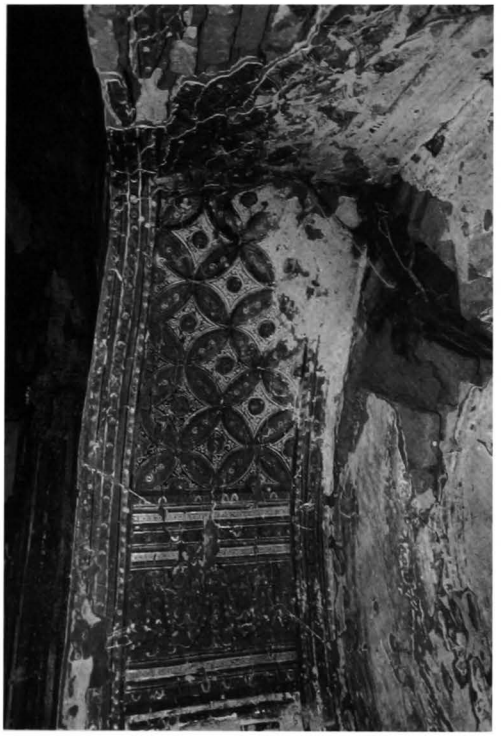
262 d - South forepart vault, from west

5 present condition
- half-ruined.
- no maintenance.

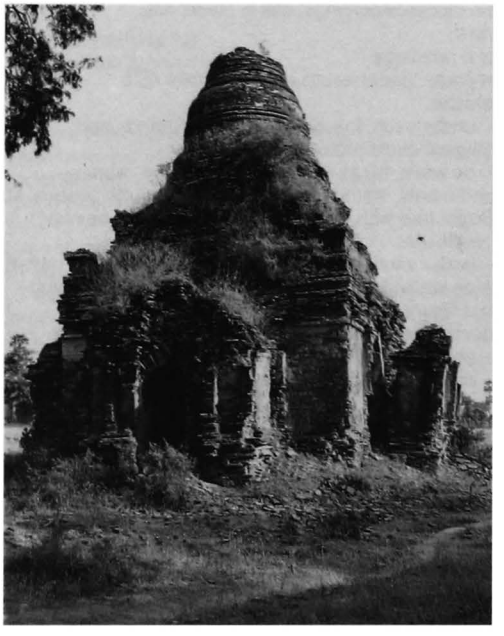
263 d - From north-west

5 present condition
- no maintenance.
- upper parts endangered.
- foreparts leaning and separated from the main body.
- base disintegrated.

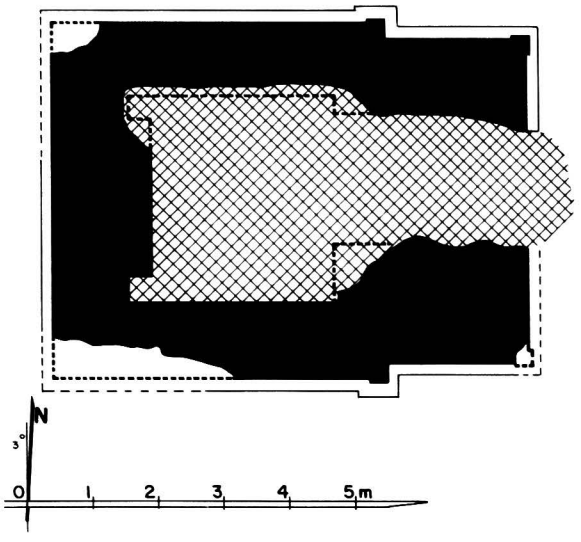
268 a - Plan

5 present condition
- ruined.
- no more trace of vaults.
- ground floor buried under debris.

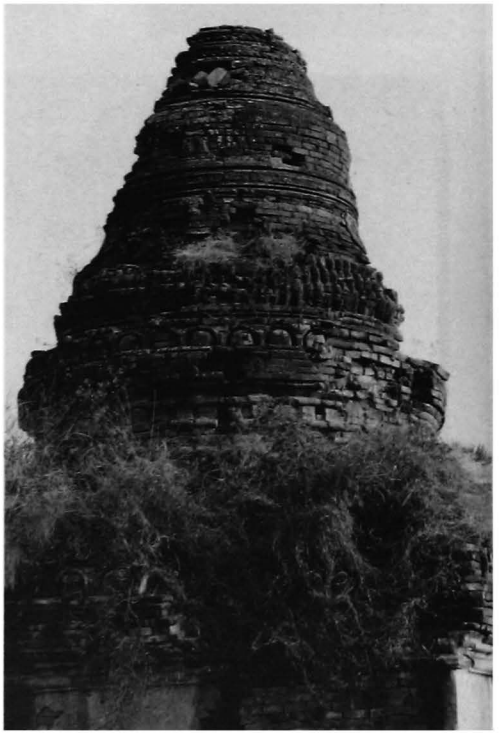
281 b - Upper parts, from north-west

5 present condition
- no maintenance.
- half-ruined.

7 decoration
exterior:
- stucco mouldings, still in place: 15%.
- dado with triangles, ornate waistband and frieze with ogre heads around dome, ornate ring at base of dome.

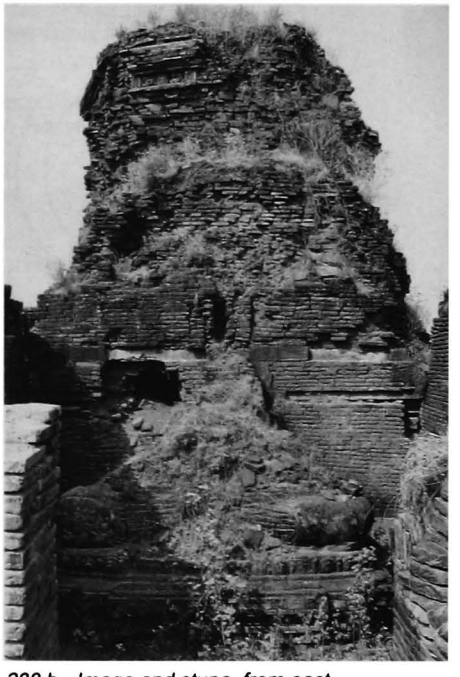
288 b - Image and stupa, from east

5 present condition
- no maintenance.
- half-ruined.
- vaults collapsed.

6 image
- 1 seated Buddha, facing east (damaged and headless).

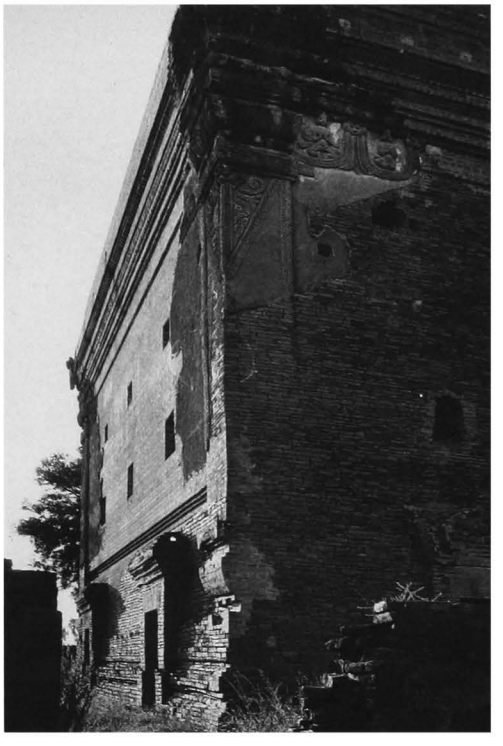
291 d - South face (May 1981)

291 e - South face (January 1985)

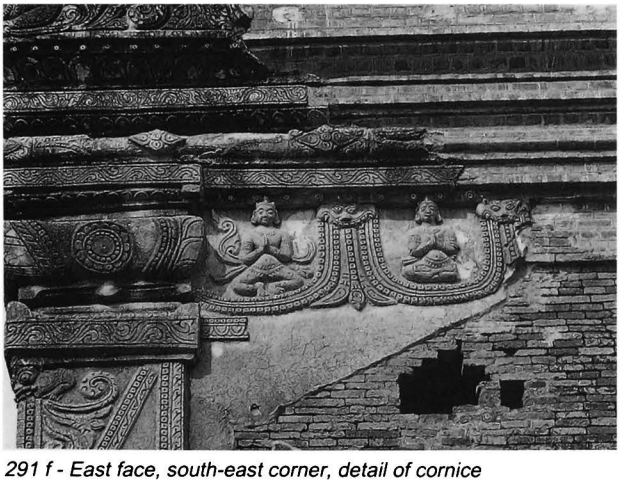
5 present condition
- regularly maintained.
- repaired (Const. Corp.) 1981 (cornice mistakenly rebuilt as continuous on east face).

291 f - East face, south-east corner, detail of cornice

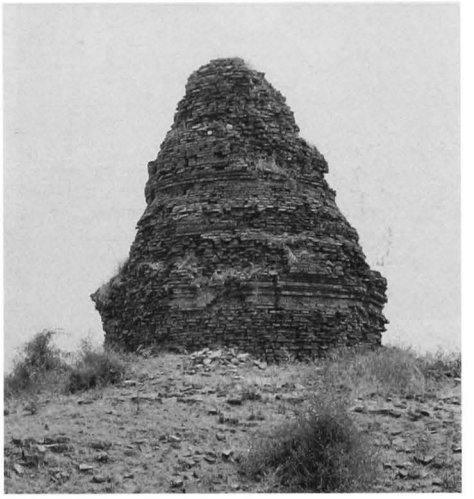
295 b - From West

5 present condition
- half-ruined.
- base buried under debris.

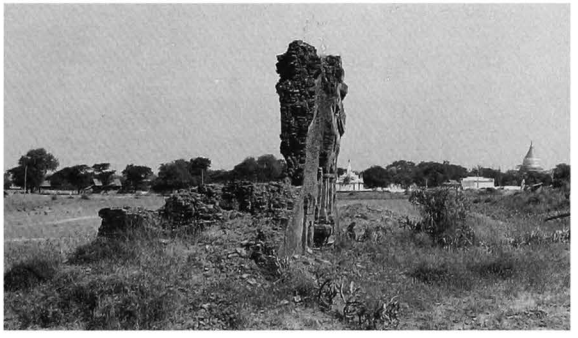
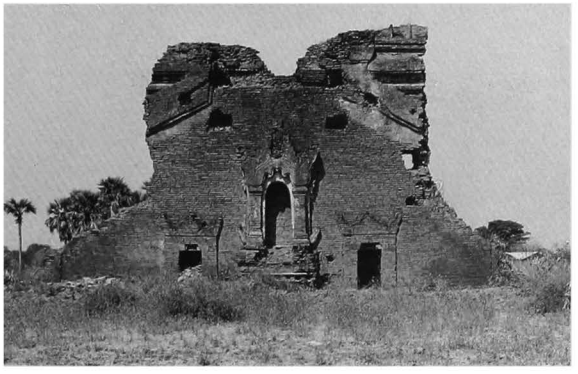
7 Pwe-zagyi-nat-kun

6 image
- image of Nat Pwe-zagyi.
- seated, facing east.

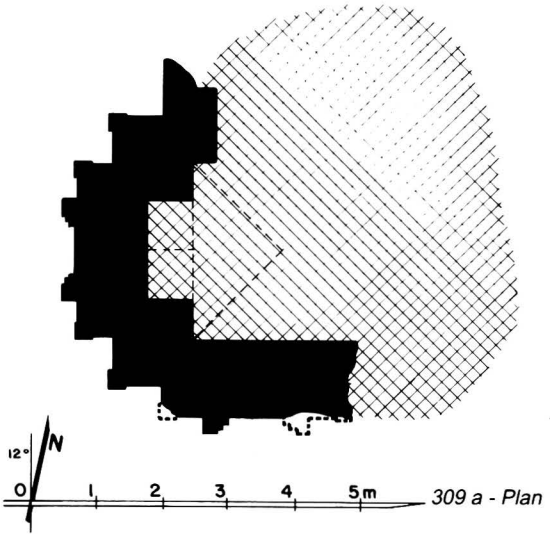
309 a - Plan

5 present condition
- ruined.
- vaults and east wall collapsed.
- ground floor buried under debris.

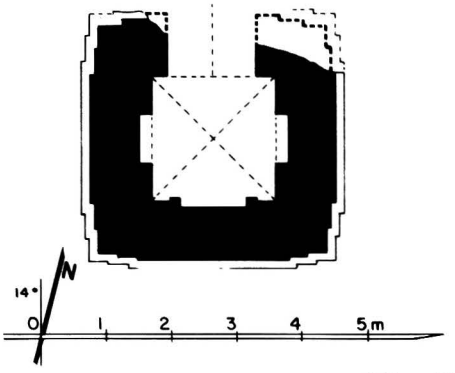
310 a - Plan

5 present condition
- half-ruined.
- vaults partly collapsed.
- north porch collapsed.

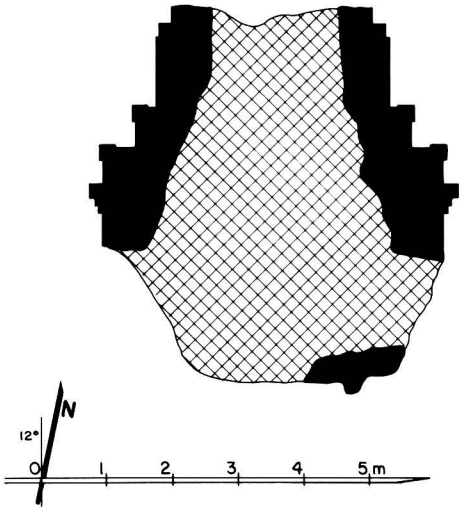
311 a - Plan

5 present condition
- ruined.
- vaults collapsed.

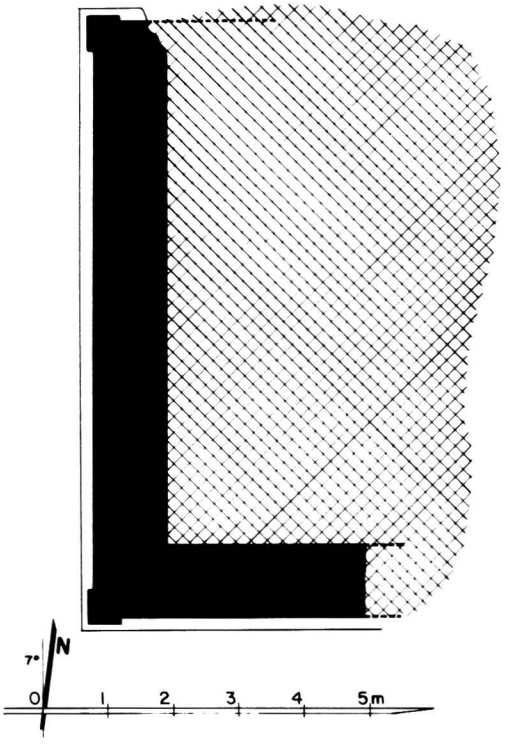
312 a - Plan

5 present condition
- ruined.
- vaults collapsed.
- ground floor buried under debris.
- only west wall remains.

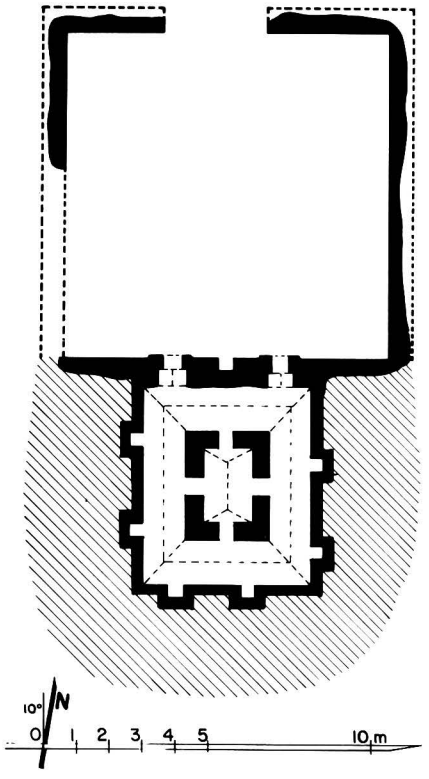
313 a - Plan

4 construction
- brick masonry, average brick: 37 x 18 x 5 cm (built with numerous broken bricks).
- barrel vault hipped at both ends over central cell.
- barrel vault over corridor.
- flat arches over doors.

5 present condition
- no maintenance.
- half-ruined.

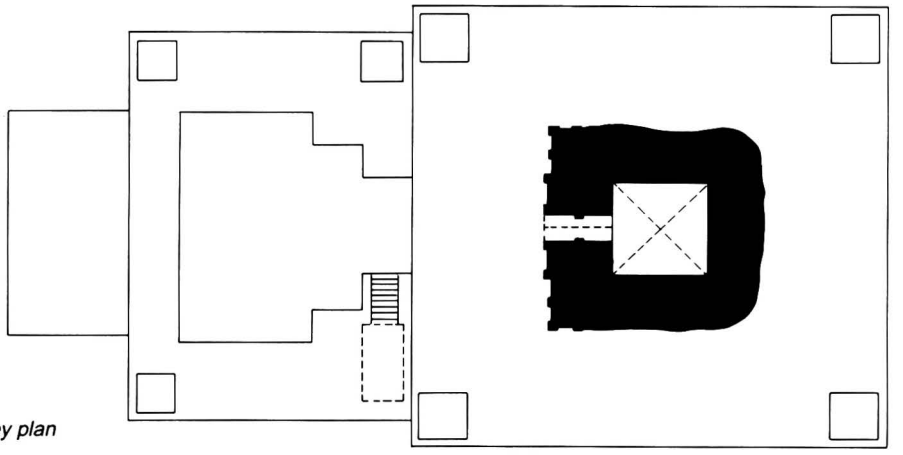
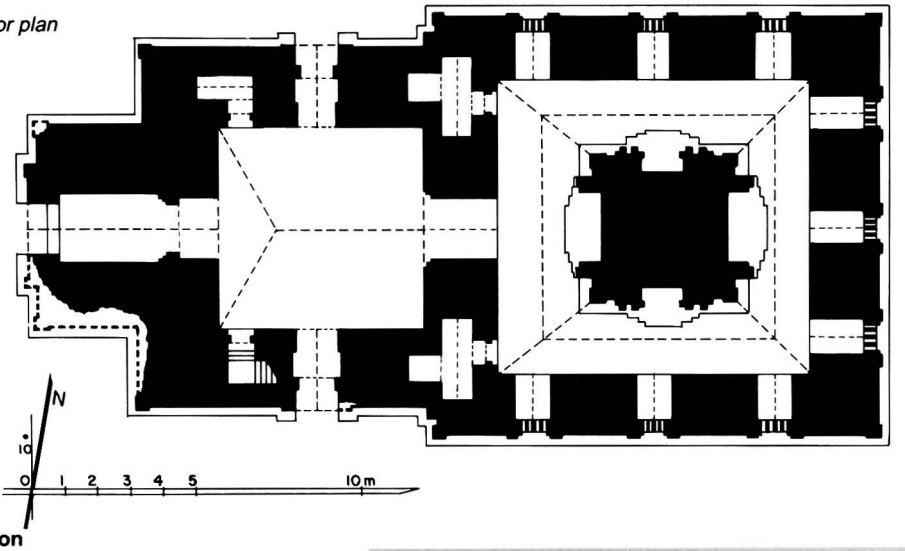
315 a1 - Upper-storey plan

5 present condition
- regularly maintained.
- repaired 1960, damaged by 1975 earthquake, repaired (Const. Corp.) 1984-5 : west porch, south wall of entrance hall, vault of east corridor and main body of upper storey reconstructed.
- brick grilles built by Dept. on lateral porches.

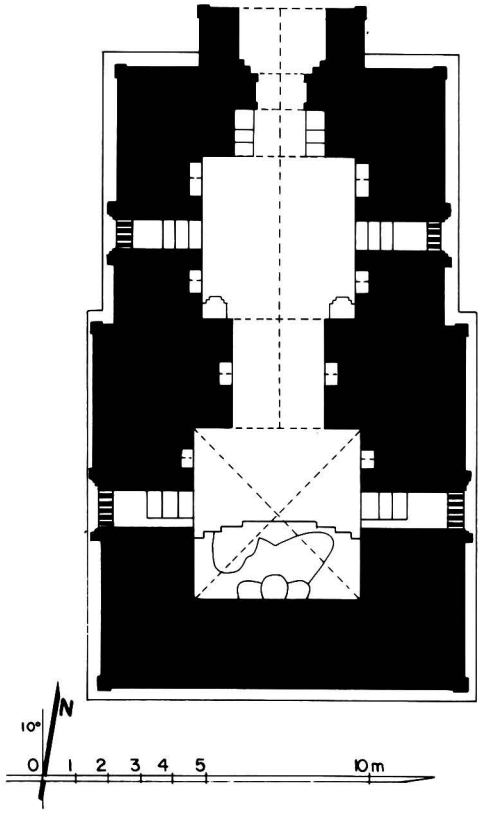
316 a - Plan

5 present condition
- no maintenance.
- repaired 1970-1.

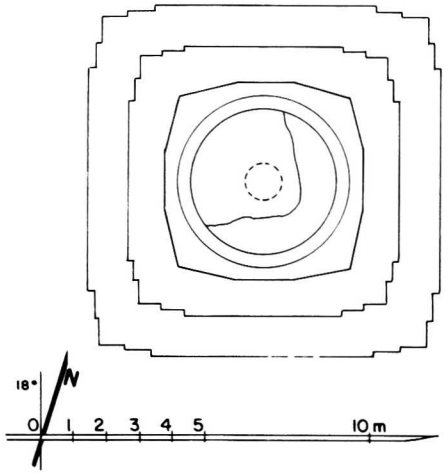
317 a - Plan

5 present condition
- upper parts not maintained.
- repaired and strengthened (Const. Corp.) 1981.

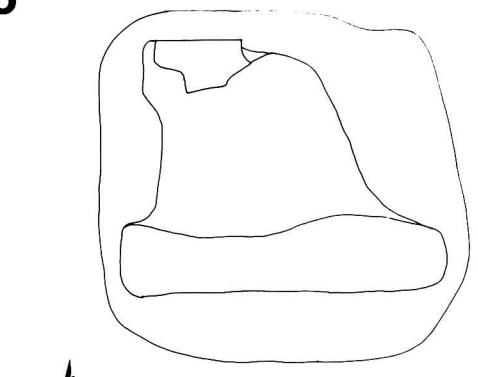
318 a - Plan

5 present condition
- base of brick walls.
- height: approx. 1.30 m.

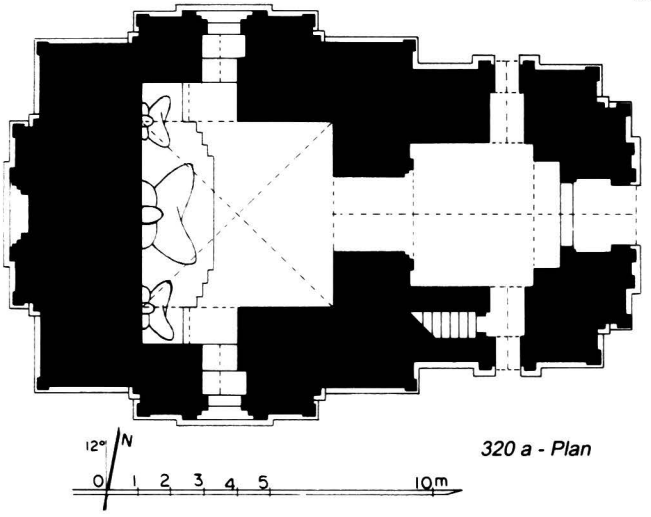
320 a - Plan

5 present condition
- upper parts partially collapsed.
- vault over entrance hall collapsed.
- terraces repaired.

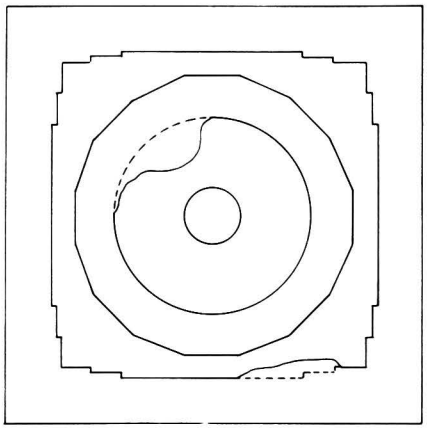
321 a - Plan

5 present condition
- no maintenance.
- terraces severely damaged.

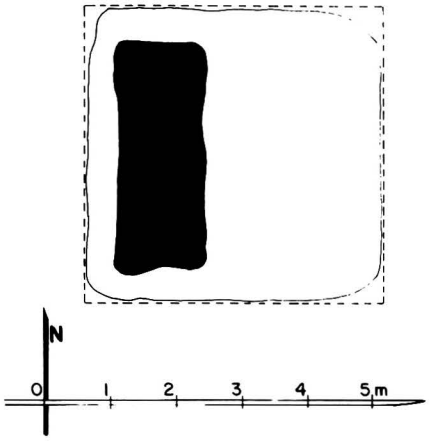
322 a - Plan

4 construction
- brick masonry, average brick: 36 x 19 x 5 cm. (mostly built with broken bricks).

5 present condition
- ruined.

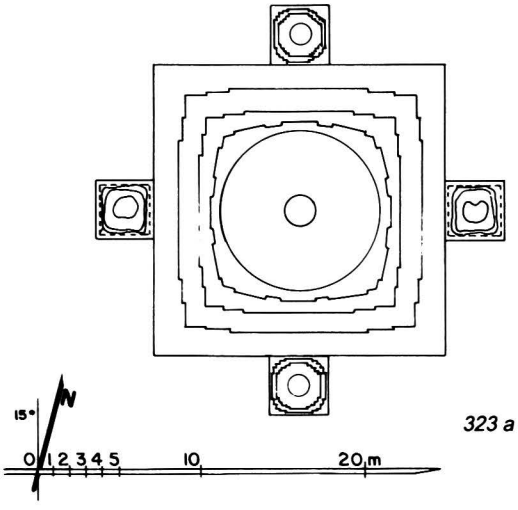
323 a - Plan

5 present condition
- no maintenance.

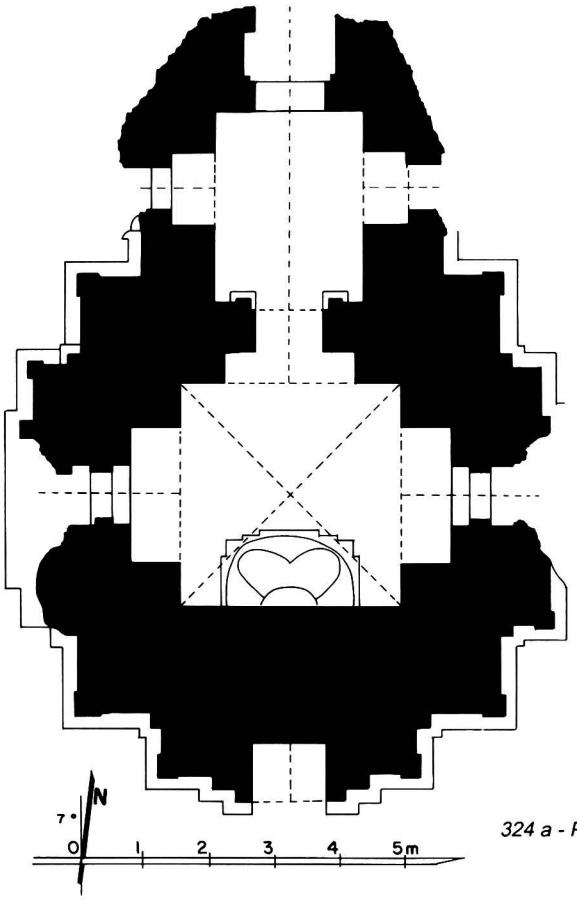
324 a - Plan

5 present condition
- entrance hall and north porch collapsed.
- repaired 1972.

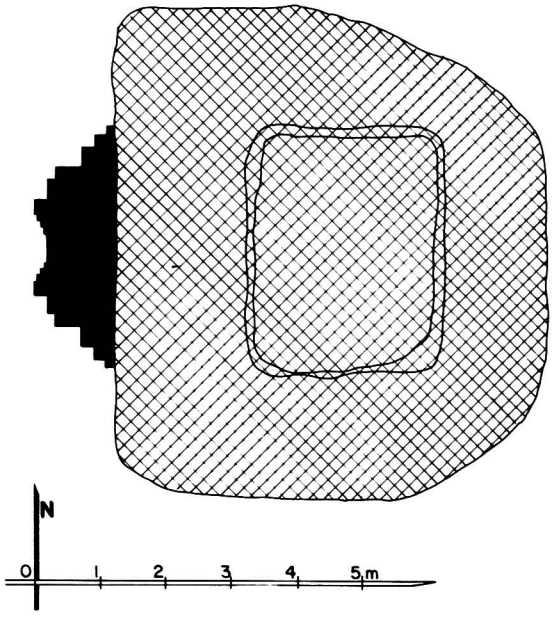
325 a - Plan

5 present condition
- ruined.
- no more trace of vaults.
- ground floor buried under debris.
- only west forepart remains.

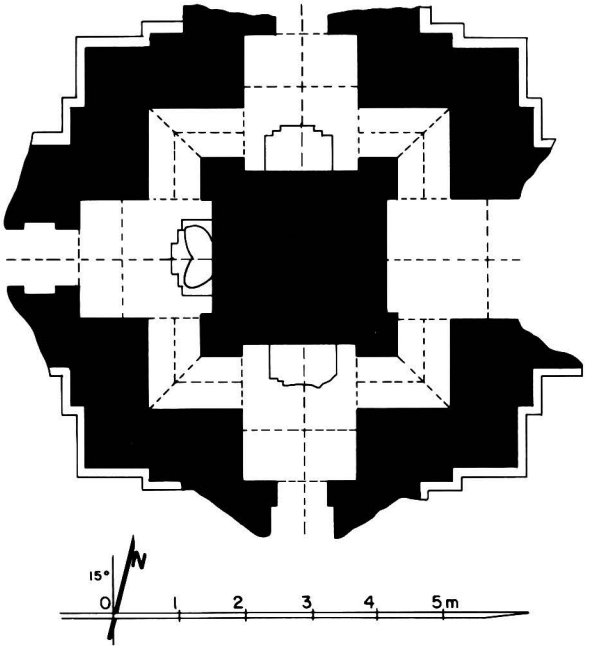
326 a - Plan

5 present condition
- no maintenance.
- half-ruined.
- porches collapsed.

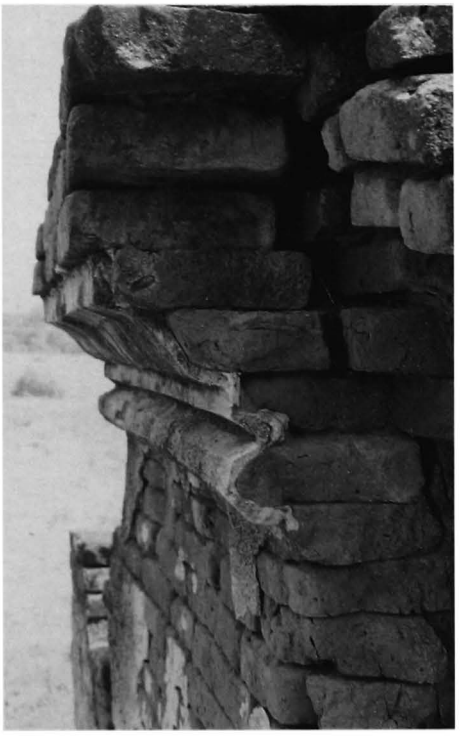
5 present condition
- ruined.
- upper parts collapsed.

327 b - From south-east

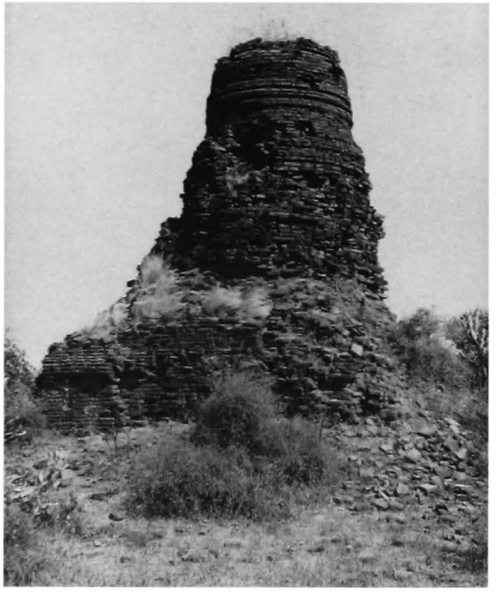
5 present condition
- no maintenance.
- ruined.
- base disintegrated.

329 b - From south-east

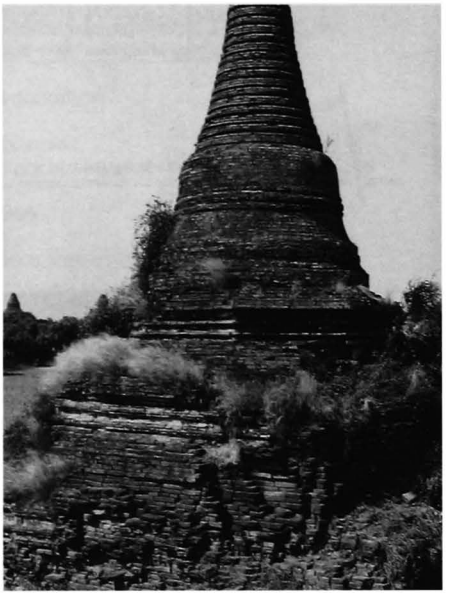
333 b - From north-east

5 present condition
- no maintenance.
- base disintegrated.

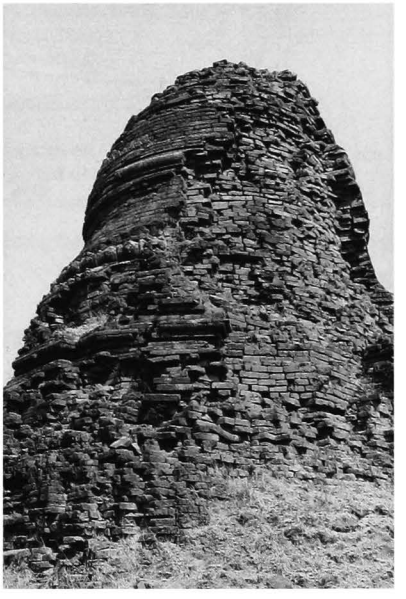
342 b - Upper parts, from south-east

5 present condition
- no maintenance.
- base disintegrated.
- upper parts heavily damaged.

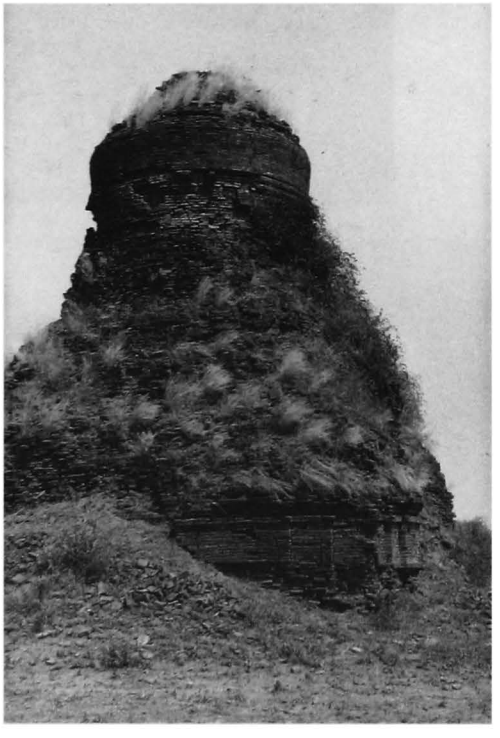
343 b - From south

5 present condition
- no maintenance.
- half-ruined.
- terraces disintegrated.

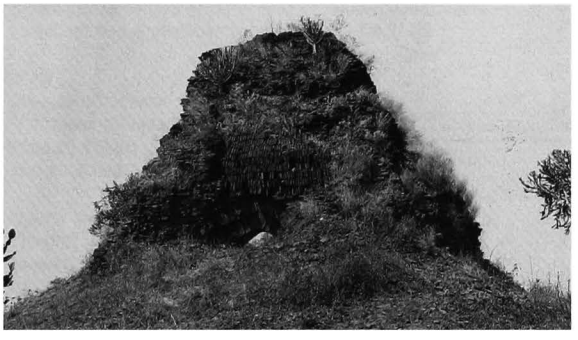
344 b - From east

5 present condition
- ruined.
- vaults partly collapsed.
- ground floor buried under debris.

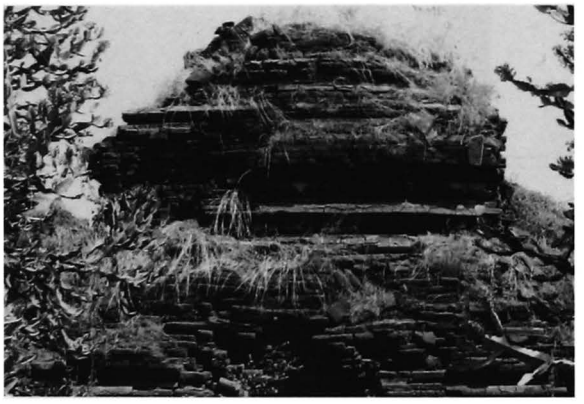
346 b - From south

5 present condition
- no maintenance.
- half-ruined.
- base disintegrated.
- upper parts collapsed.

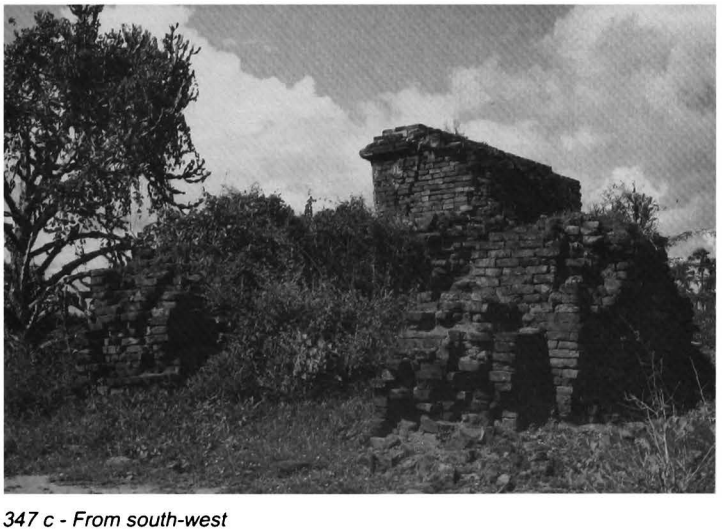
347 c - From south-west

5 present condition
- ruined.
- vaults collapsed.
- ground floor buried under debris.

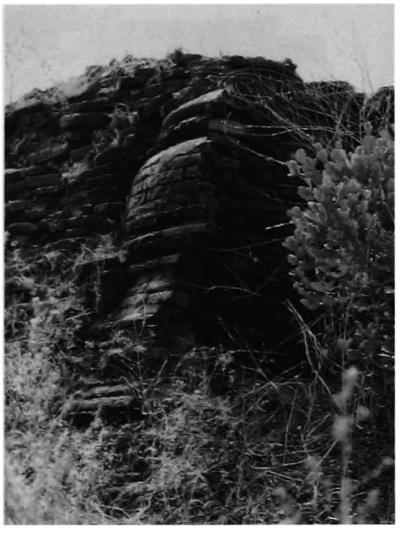
348 b - Encased stupa, from north-west

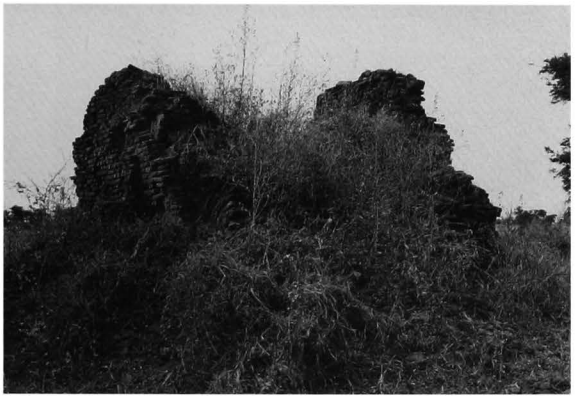
5 present condition
- ruined.
- vaults collapsed.
- ground floor buried under debris.

349 b - From north-west, together with 350

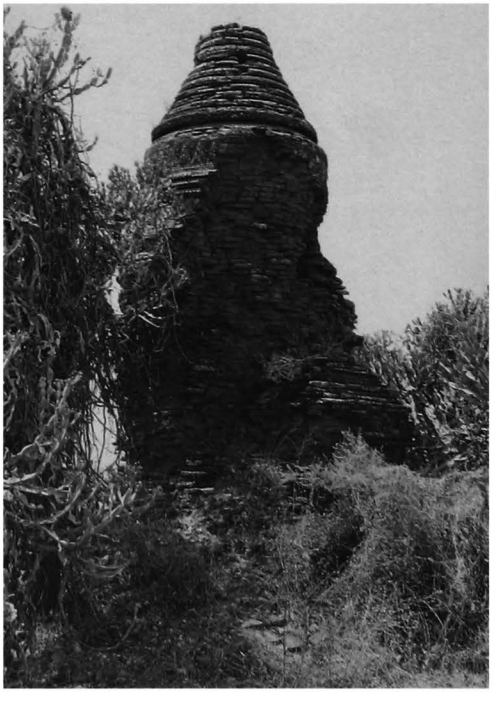
5 present condition
- no maintenance.
- half-ruined and endangered.
- base disintegrated.
- upper parts heavily damaged.

350 b - From south

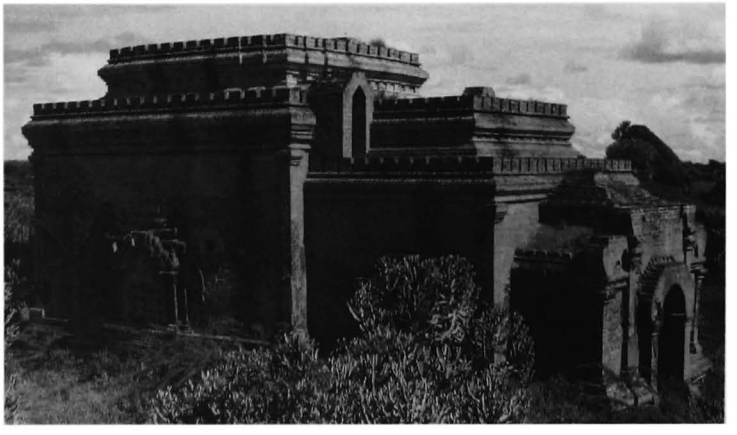
5 present condition
- upper parts collapsed.
- repaired (Const. Corp.) 1984-5.

352 b - West face (1988), from north-west, after repair

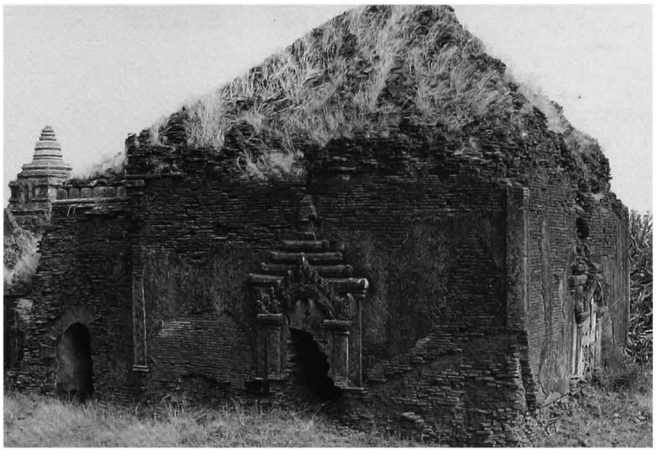
352 c - From north-west (1992), after repair

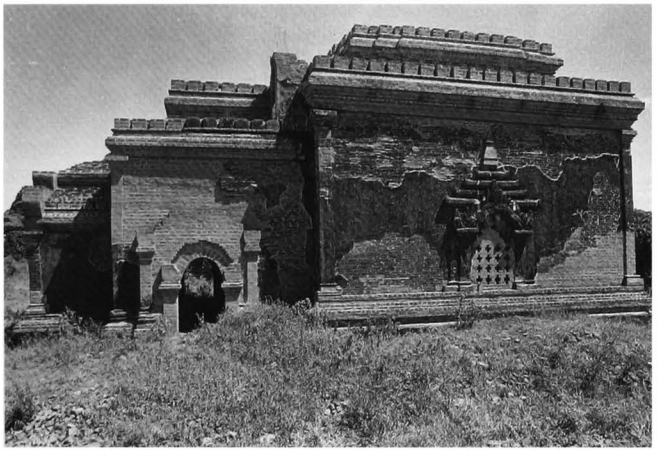
352 d - South face (April 1984), from south-east

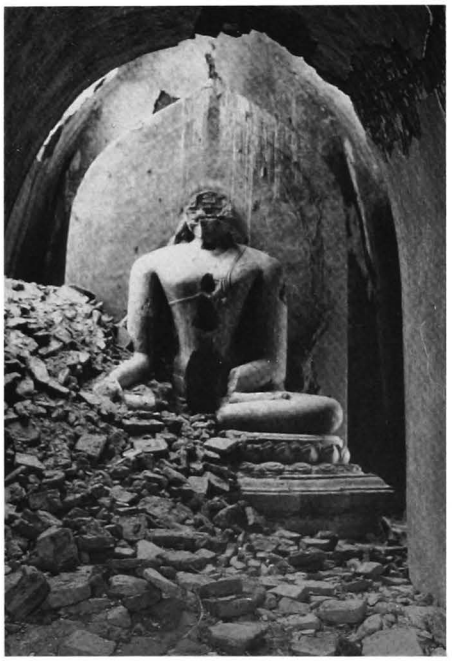
6 image
- 1 seated Buddha, facing west (damaged and headless), against a screen wall.

352 g - Image and screen wall (April 1984)

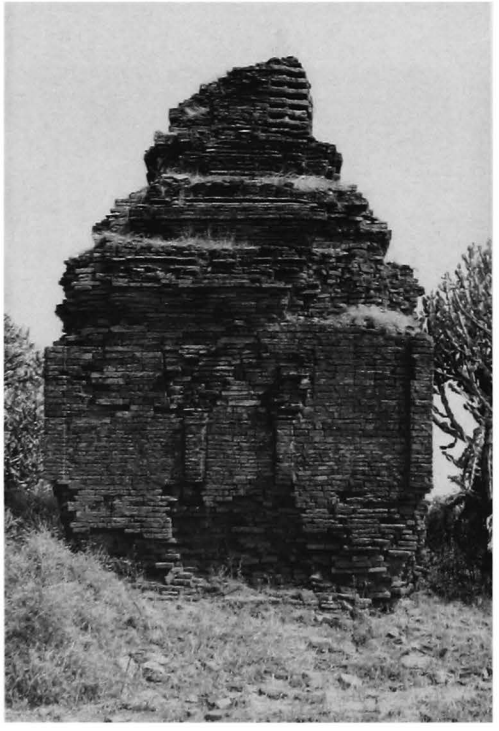
5 present condition
- no maintenance.
- upper parts heavily damaged.
- repaired (Dept.) 1979, 1988, 1991.

353 b - South face

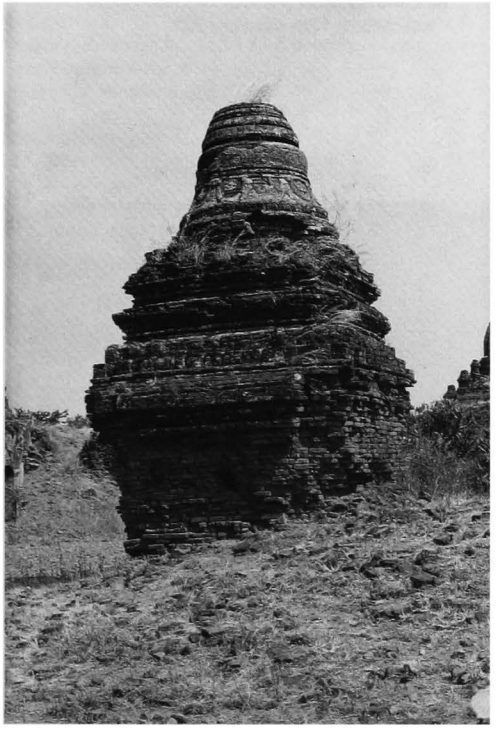
354 b - From south-east

5 present condition
- no maintenance.
- half-ruined.
- base disintegrated.

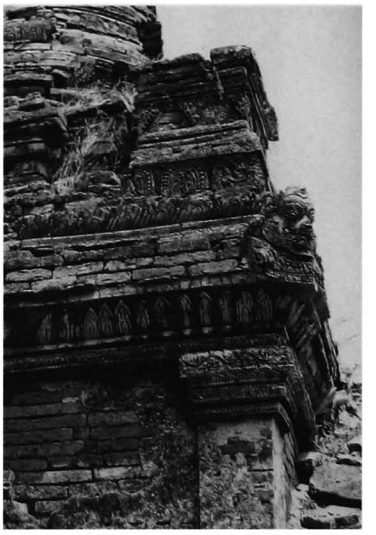
355 e - South-east corner, cornice

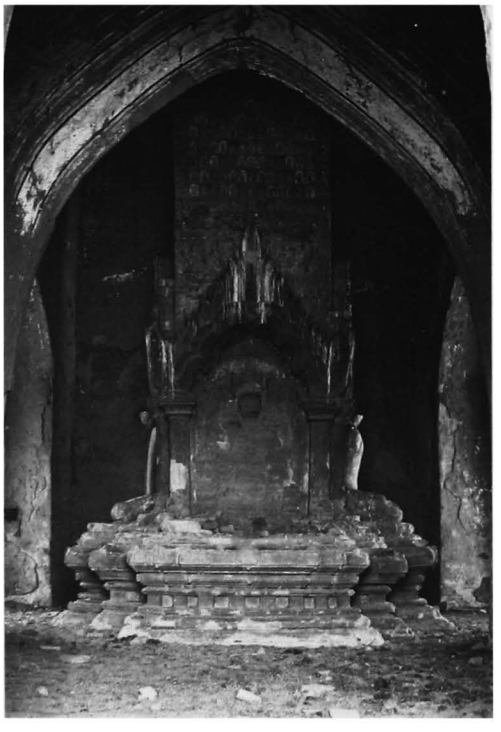
359 g - Shrine, central pillar and north image

6 images
- 4 seated Buddhas, against the central pillar (destroyed on north, damaged and headless on east, south and west).
